MCDONNELL DOUGLAS PAPER
MDC 95K0074

AN OBJECT LESSON IN FALSE ECONOMIES –
THE CONSEQUENCES OF *NOT* UPDATING REPAIR PROCEDURES
FOR OLDER ADHESIVELY BONDED PANELS

by
L. J. HART-SMITH
MCDONNELL DOUGLAS AEROSPACE
and
M. J. DAVIS
ROYAL AUSTRALIAN AIR FORCE

presented to
41st SAMPE INTERNATIONAL SYMPOSIUM AND EXHIBITION
Anaheim, California
March 25-28, 1996

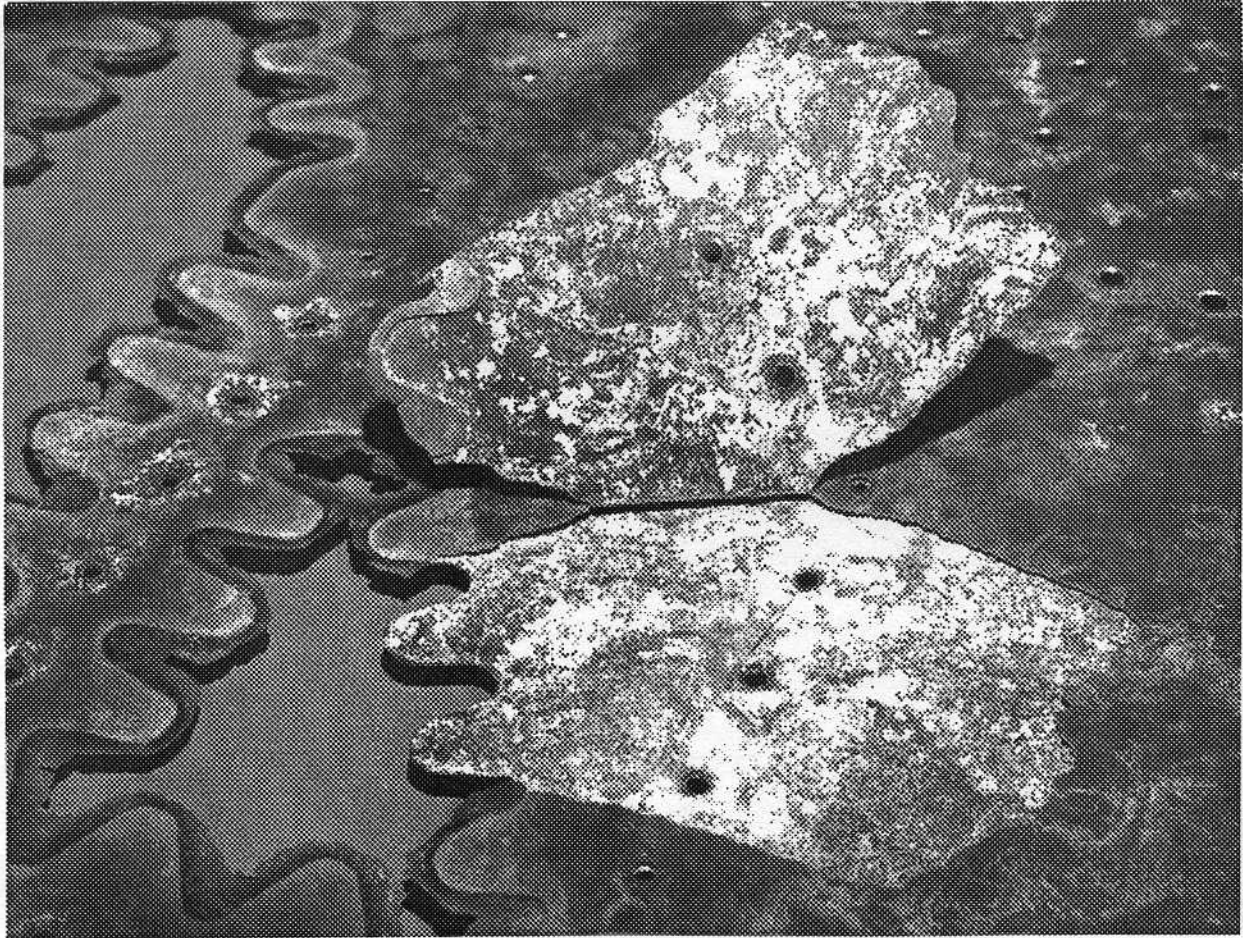
FIG. 1 CORRODED ADHESIVELY BONDED PANEL MANUFACTURED WITHOUT ANODIZING THE SURFACE, USING THE ORIGINAL UNCONTROLLED FPL ETCH

Figure 1 is typical of the corroded bonded panels made by etching the surface in the solutions used *before* the development of the optimized FPL etch. Figures 3 and 4 show a different kind of failure, with absolutely no sign of corrosion, on which more will be said later in the paper. In the short term, the resin injected through the many holes drilled in the facings may have concealed the disbond for long enough to pass the ultrasonic inspection to which the panel would undoubtedly have been subjected. However, when they failed again, at the same time as the surrounding areas which had not yet fallen apart when the previous repairs were made, the repairs lifted cleanly off the surface, leaving no adhesive behind. This is the classic sign of bond failure not by mechanical fatigue but by environmental attack. The only thing new about Figure 4 is the combination of such a widespread area of disbonding and the lack of corrosion. Even the core is intact.

While the water absorbed by the first generation of 250°F-curing adhesives definitely played a part in the interfacial failures of the bonds, the same adhesives have since been used quite successfully with the PABST primers and surface preparation. It is not the water *in* the adhesive which does the harm, it is water allowed to penetrate to the aluminum *surface* which fails the bond. Significantly, not all of it gets there through the adhesive layer itself. Some passes along continuous fibers in woven or knitted carriers in the adhesive film, which is why mat carriers made from discontinuous whiskers are to be preferred. The most common initiation points for interfacial bond failures, however, have been fastener holes and edges trimmed on assembly. In both cases, the protection of both the primer and anodize (or etch) has locally been removed. Coating these areas with rubber-based sealants creates a new water-impervious barrier. Without it, the interface will fail progressively unless the surface is so inert as not to react with water. Absorbed water first separates the substrate from the primer (or adhesive). This creates a crevice in which far larger quantities of free-standing water accumulates. This area will then corrode, as the water permeates further forward, creating more disbonds, which are initially free from corrosion. The problem has been found to be particularly bad with clad 7075 alloys and 250°F-cured adhesives. In this case, the cladding acts as a sacrificial coating, like galvanizing on corrugated steel roofs. The corrosion is easily visible, but the defective bond extends far ahead of it. Indeed, when this phenomenon is observed, there are three conditions present in the structure; those areas which have already corroded, those which have disbonded but are yet to corrode, and the remainder which is *about to fail*, no matter how many times it is inspected ultrasonically. These phenomena are illustrated in Figures 1 and 2, taken from PABST reports and the more recent Reference (1), in which it was recommended that the only sensible response to this condition is a total disassembly, replacement of corroded components where necessary, reprocessing of each and every detail using *new* processes (not the ones which had led to the corrosion in the first place), followed by a *total remanufacture*, *NOT* a *local* repair.

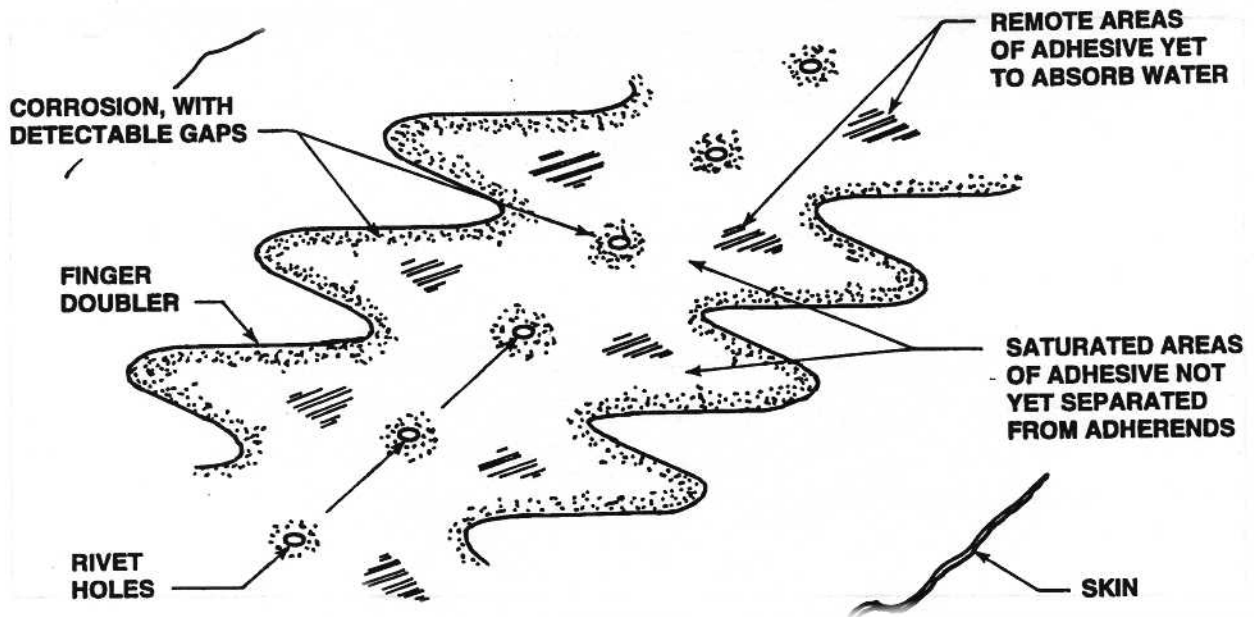
FIG. 2 PROGRESSIVE FAILURE PROCESSES AS WATER PENETRATES ALONG THE BOND

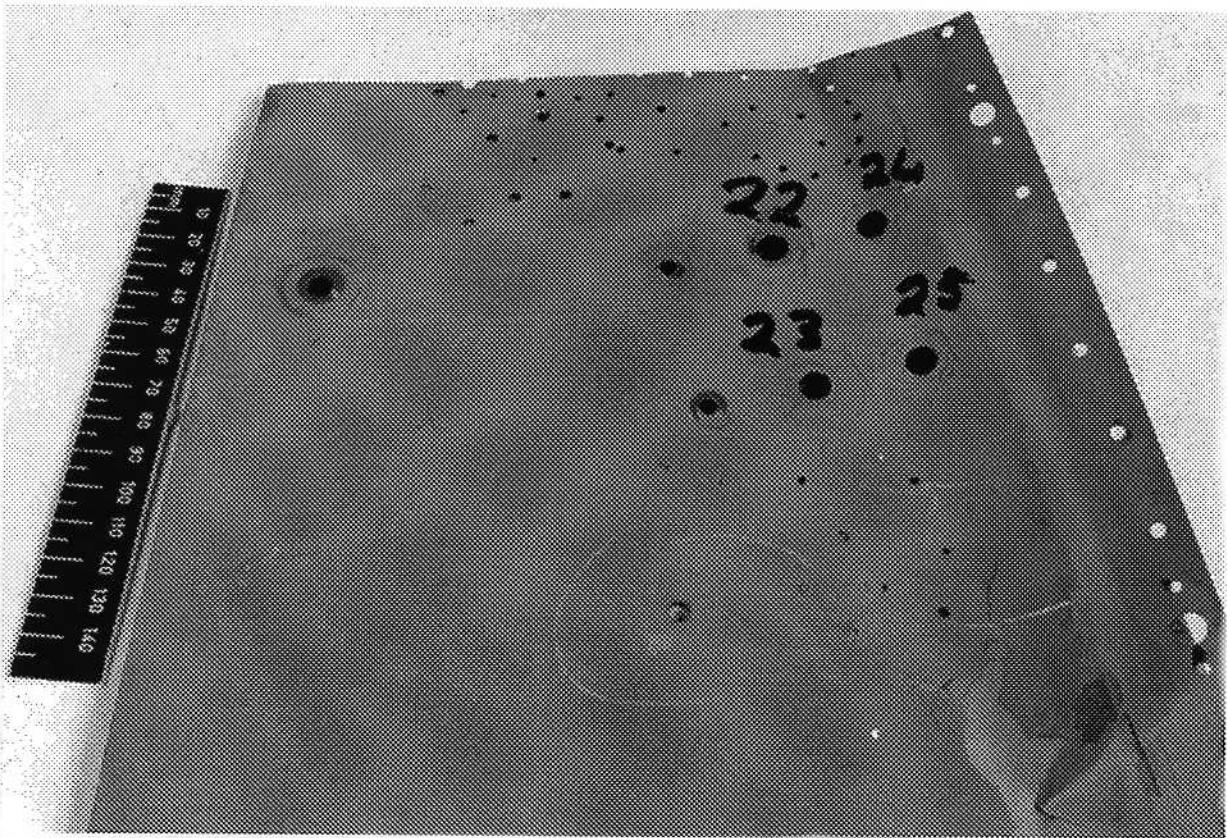
FIG. 3 EXTERIOR OF SUPPOSEDLY BONDED HONEYCOMB PANEL, SHOWING INNUMERABLE SMALL HOLES USED TO INJECT RESIN TO MAKE IT IMPOSSIBLE TO DETECT THE DISBONDS (UNTIL THEY HAD OPENED UP AGAIN)

The exterior of the skin shown in Figure 3 gives little indication of the extent of the internal damage. In the lower right corner, the exterior skin is seen to have cracked by acoustic fatigue once a sufficiently large area had become detached from the core. Otherwise, this skin (and the opposite one which is not illustrated here) look in quite good condition. However, virtually the

the circumstances whereby someone concluded that the extent of the internal damage was far more widespread than inspection from the outside had indicated it is not recorded. It is obviously a very good thing that this “someone” did not merely perform more repairs like the *second set*, only to have them fail yet again. Yes, this panel had *already* been repaired *TWICE – IN THE SAME PLACE!* Although the demarcation line is not clear in the reproduced photograph in Figure 4, the repair at the right hand end is actually *two* repairs. The tear-drop shaped piece of visible core in the lower right corner of what seems to part of a *single* blob of injected repair adhesive is part of this demarcation. Also, the skin in the bottom right of Figure 3 did not shake itself to death until *after* it had separated from the core.

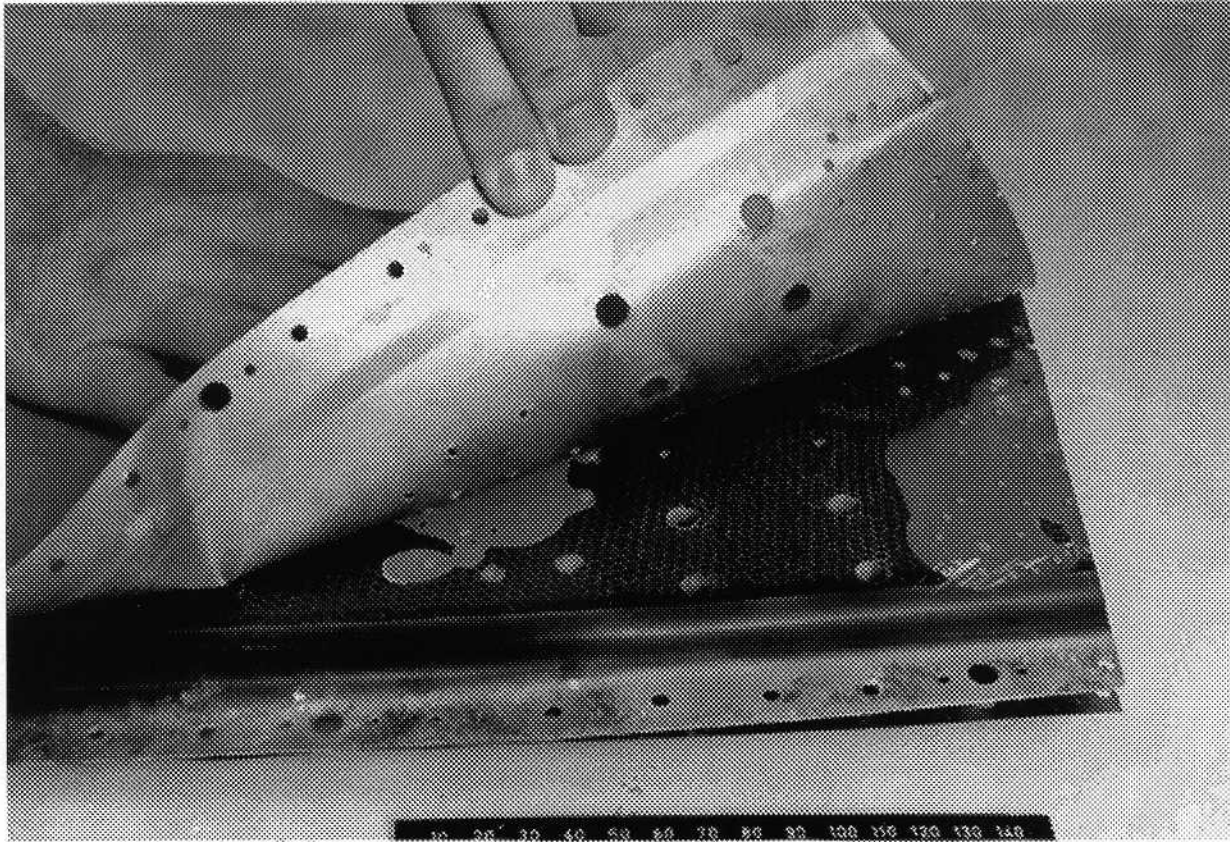
FIG. 4 INTERIOR OF THE SAME PANEL, SHOWING HOW THE INJECTED RESIN (TWO LIGHT GREY AREAS) HAD FAILED TO ADHERE ANY BETTER THAN THE ORIGINAL BOND, TO A SEALED CHROMIC-ACID-ANODIZED SURFACE

entire right-hand half of the skin in Figure 3 was actually detached from the core, as revealed by peeling it back in Figure 4. The lower-right corner of Figure 4 corresponds with the upper-right corner of Figure 3. The larger holes in Figure 3 are bolt holes. So are the smaller holes against a white background along the right-hand edge. The small black holes in Figure 3, mainly at the far end, look as if they were drilled to inject repair resin, in accordance with the specified procedures of the day. Actually, as can be seen in Figure 4, most of them were drilled at a far later date, to map the extent of what was at first believed to be a “new” disbond when it was discovered at the *most recent* inspection. However, almost as many of these holes were in the previously “repaired” area as are to be found alongside in the previously unrepaired areas. Most of the holes in the old repair have passed through the skin into the repair adhesive, clearly visible in two areas in Figure 4, so they could not possibly have been left over from the original repair.

The more troubling information contained in Figure 4 is the total absence of the corrosion, which was so unmistakable in Figure 1, and the lack of damage to the core as the initial disbond was opened up to photograph it. A properly formed and bonded adhesive fillet along the ribbons in the honeycomb is more than strong enough to rip the core apart. Yet, here, it simply lifted off the skin, just as the explanation in Figure 2 suggests that it would. The absence of small holes in the skin suggests that the area between the two old repairs (in the middle and the right of Figure 4) had passed the most recent ultrasonic inspection. Yet it was clearly not bonded. Unfortunately,

The reason for the lack of corrosion was explained 20 years ago during testing performed during the PABST program.. The details were chromic-acid anodizing to create a stable oxide surface covered with closely spaced pits for the primer or adhesive to grip onto. Then in accordance with the specifications under which the panel was manufactured, they was dunked in very *hot* water. The reason for doing so was to *seal* the pores to prevent corrosion. This techniques obviously works very well for that purpose; but it does *not* permit the glue to stick, which *should* have been the reason for the anodizing in the first place. It was only while investigating these two figures that the senior author learned that Robert Schliekelmann, Fokker’s famous bonding expert, was well aware of this phenomena. He deliberately chose *not* to seal the chromic-acid-anodized surfaces on his bonded panels during processing. This allowed the phenolic resin to lock into the pores on the surface where the bonding *was* to occur and the steam generated at 350°F during the cure of the phenolic adhesive to seal the *rest* of the surface to protect it against corrosion where the bonding was *not* required. What more could one ask for in the form of a durable bond and a structure protected from corrosion? For precisely analogous reasons, *100 percent* of the phosphoric-acid-anodized surfaces treated in accordance with the PABST processing are covered with corrosion-inhibiting primer. Otherwise, the waffle grid formed by the bonded areas would survive for ever, but the unbonded areas in between would all corrode far faster than if they had been left as bare aluminum alloy.
