DAVIS, M.J., Chester, R.J., Perl, D.R., Pomerleau, E., Vallerand, M., *Honeycomb Bond and Core Durability Issues; Experiences within CREDP Nations*, Aging Aircraft Conference, Williamsburg, VA, Aug 31-Sep 02 1998.

## **HONEYCOMB BOND AND CORE DURABILITY ISSUES; EXPERIENCES WITHIN CREDP NATIONS**

M.J. Davis, R.J. Chester, D.R. Perl, E. Pomerleau, M. Vallerand<sup>1</sup>  
F/A-18 Composite Repair Engineering Development Program (CREDP)

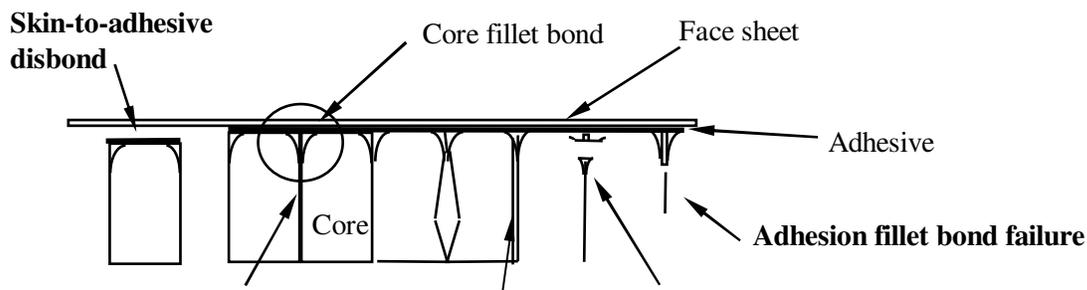
A common form of failure of sandwich panels is due to a *skin-to-adhesive disbond* at the interface between the adhesive layer and the face sheet (see Fig. 1). Most aircraft operators experience this type of failure which typically results in a complete absence of adhesive on the separated skin material. Another common form of failure, *cohesion fillet bond failure*, occurs when the flatwise tension strength (FWT) of the adhesive fillet is exceeded, typically due to internal pressure generated during heating. The adhesive fractures, leaving the adhesive on the face sheet and core cell walls.

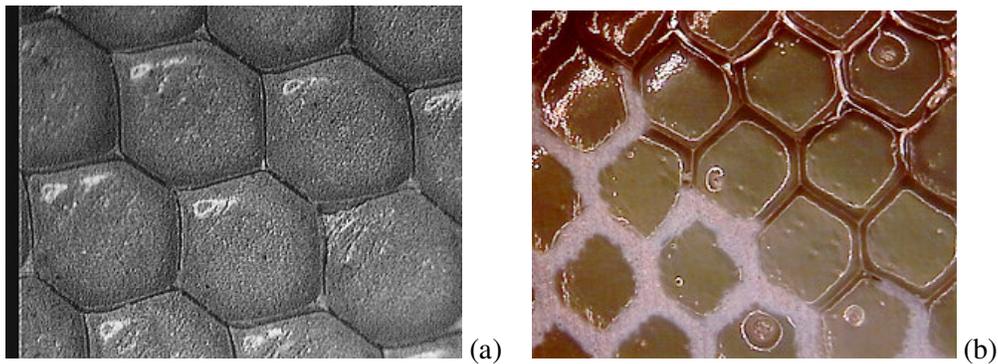
*Adhesion fillet bond failures* are identified by a “slick” separation of the core from the face sheet adhesive layer. There appears to be no damage to either the core or adhesive, with the core cells pulling neatly out of the adhesive layer (see Fig. 2 (a)). Damage to the adhesive layer and tearing of the core is minimal. In contrast, a strong bond between the core and adhesive fails by either fracturing the adhesive or by tearing of the core foils (See Fig. 2 (b)). In some cases of adhesion fillet bond failure, the skin has been removed so easily and the core appears to be in such good condition that technicians have attempted to bond a repair onto the old core (see Fig. 3).

Figure 2. (a) Photograph of an adhesion fillet bond failure surface from an F-111 glove panel failure, showing the clean separation of the adhesive from the core. (b) The failure surface after separation of an effective bond, with cohesion fracture of the adhesive (lower left) and tearing of the core foils (upper right).

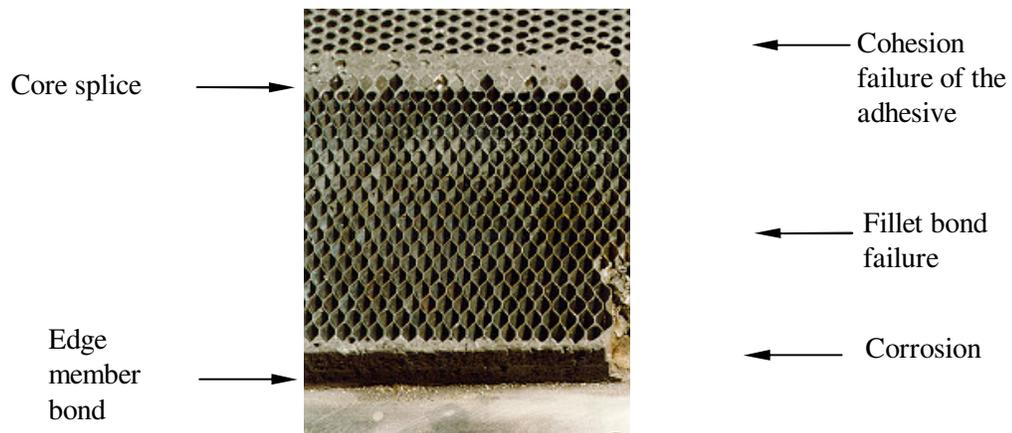
Figure 3. Failed sandwich panel showing cohesion failure and adhesion fillet bond failure.

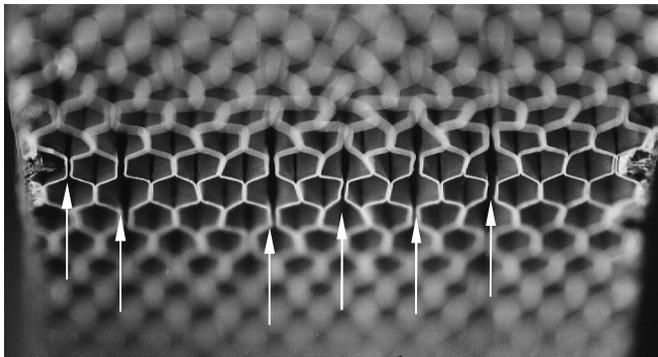
*Node bond failures* are characterised by separation of the cell wall node bonds along the ribbon direction (see Fig. 4). Although the separation may occur as simple disbonding of the cell walls, failures may also exhibit cell wall distortion due to pressure caused by moisture vaporising at elevated temperature (see Fig. 5). Node bond failures frequently occur during application of heat for cure of adhesive bonded repairs. The typical “freeze-thaw” cycle may also cause pressure on the cell walls if ice forms in the cells, although typically the amount of trapped water is usually insufficient to generate the required pressures.

Figure 4. Node bond failures in aluminium core, showing the separation of the cell node bonds along the ribbon direction after exposure to slow cycle fatigue at a hot-wet tropical site.

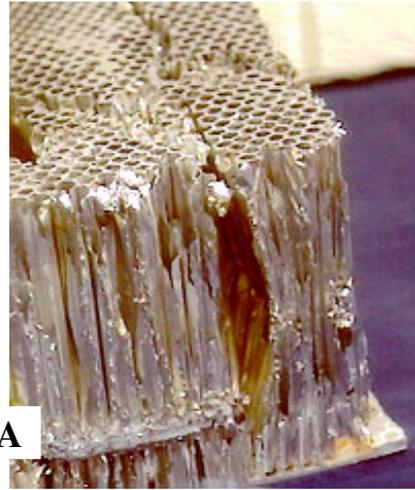
Figure 5. Node bond failure and cell wall distortion at “A” caused by internal pressure in aluminium core.

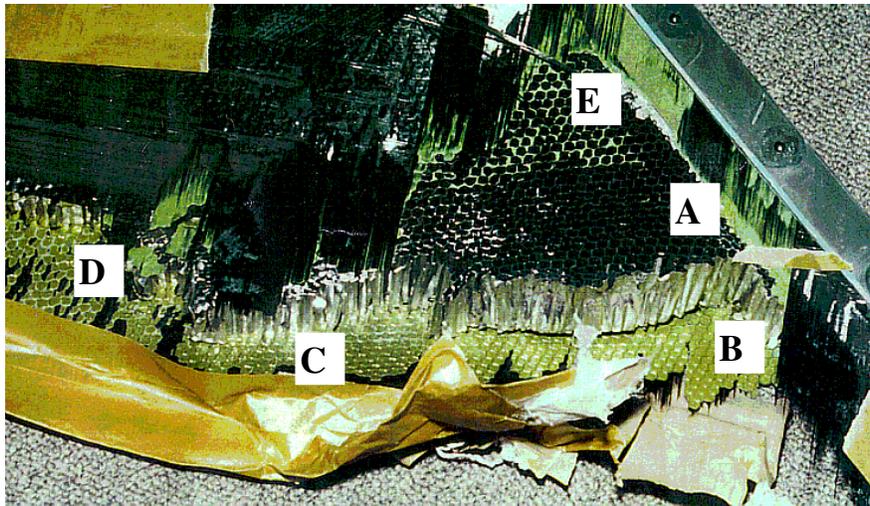
A number of in-flight failures have occurred due to adhesion fillet or node bond failures, resulting in severe damage and/or loss of control surfaces and structural panels on USN F/A-18. After the USN raised the issue of such damage mechanisms causing structural failures, a review of defect reports from other CREDP member fleets also identified the characteristics of these failures. Investigation of one failed F/A-18 graphite/epoxy skinned rudder (Fig. 6) shows that on a significant proportion of the failed surface there is minimal core fracture and negligible damage occurring to adhesive which was still bonded to the inner surface of the face sheet. Areas A and B show complete adhesion failure while areas C and D exhibit evidence of mixed cohesion and adhesion failures. The absence of adhesive on the ends of the core cells and the absence of fractured core are indicative of adhesion fillet bond failure. In contrast, the adjacent area (E) displays a typical cohesion peel failure, with fractured adhesive left on the cells.

Figure 6. Photograph of a failed F/A-18 composite skinned rudder. A and B show complete adhesion failure while areas C and D exhibit evidence of mixed cohesion and adhesion failures, and peel failure (E). Note that protective tape has been applied for safer handling.

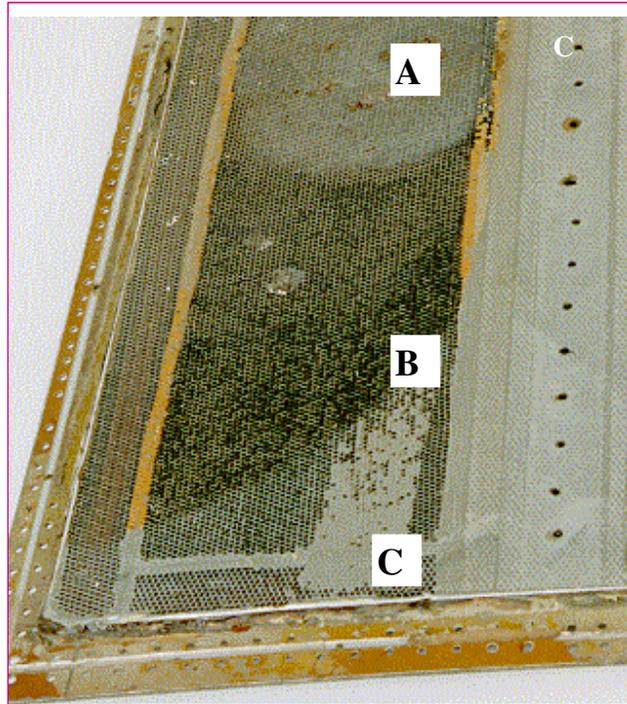
The RAAF has also experienced core adhesion fillet bond failures on a fixed glove panel on F-111 (see Fig. 7). This defect became apparent when the inner skin separated from the core region during an attempt to perform a hot-bonded repair in the adjacent panel bay. The figure shows light corrosion around previous injection repairs (A) and a large area of adhesion fillet bond failure (B), where the skin simply lifted off the core. Less than 10% of the panel exhibited a cohesion peel failure through the adhesive (C) during break-down for rebuild. All of the remaining panels on this component displayed similar fillet bond degradation.

Figure 7. An F-111 fixed glove sandwich panel showing light corrosion at injection repairs (A), adhesion fillet bond failure (B) which occurred in service and peel failure (C) caused during break-down of the panel for rebuild.

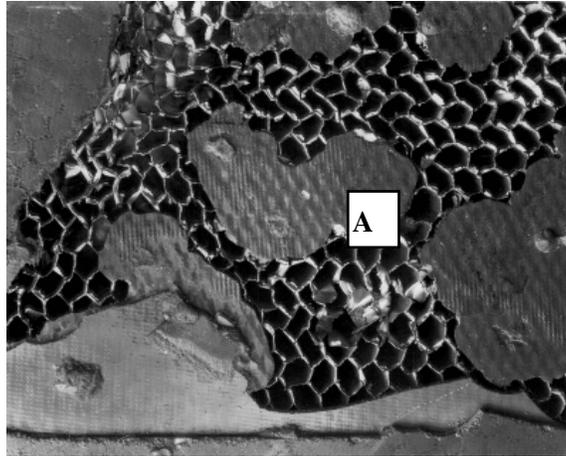
Fillet bond failure is visible on the surface of an F-111 over-wing fairing recovered after an in-flight failure (Fig. 8). The adhesive shown on the surface is from injection “repairs”. Note also that the cast impression at “A” of the matching bonding surface clearly show the core pattern. This indicates that the original defect, prior to injection repair was adhesion fillet bond failure. This large panel separated in flight causing extensive damage to the fin leading edge, rudder, horizontal stabilator and fuselage. In another USN in-flight failure, a trailing-edge flap upper-skin separated adjacent to a large repair. Core adhesion fillet bond failures were observed in conjunction with widespread node bond failures.

Figure 8. Failure surface from a recovered section of an F-111 over-wing fairing lost in flight.

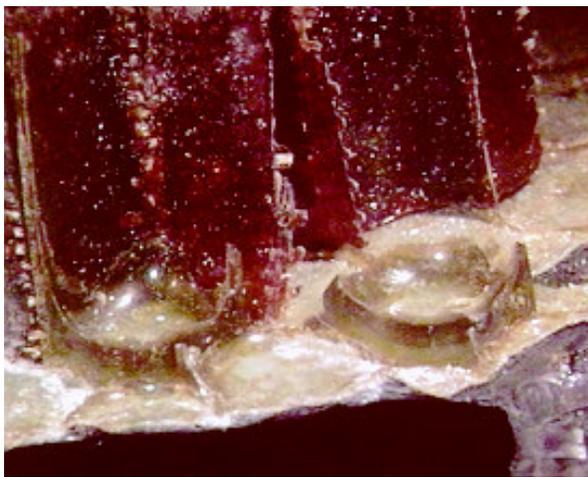
There is evidence of similar failure modes on civil aircraft, although there is no clear identification of the damage types. The FAA has issued an Airworthiness Directive AD 90-12-13 for the inspection of Airbus A310 rudders for disbonds, with the description of the problem being very similar to that experienced by the CREDP members. Inspection of Airbus elevators from one Australian civil airline revealed skin-to-core disbonds which when investigated under a low power microscope revealed core node and adhesion fillet bond failures. Concerns were expressed by the airline when the size of a disbond identified using the recommended NDI procedures was found to be less than 20% of the actual size of the core fillet bond failure found during damage removal. A later draft AD to update disbond inspection procedures was issued under Rules Docket No. 96-NM-65-AD. These Airbus elevators are fabricated with graphite/epoxy skins on Nomex™ core. Elevator core samples were inspected by the RAAF and found to have similar failure modes to those experienced in aluminium cored sandwich panels (see Fig. 9).

Figure 9. Adhesion fillet bond failures in Nomex™ core from an Airbus elevator.

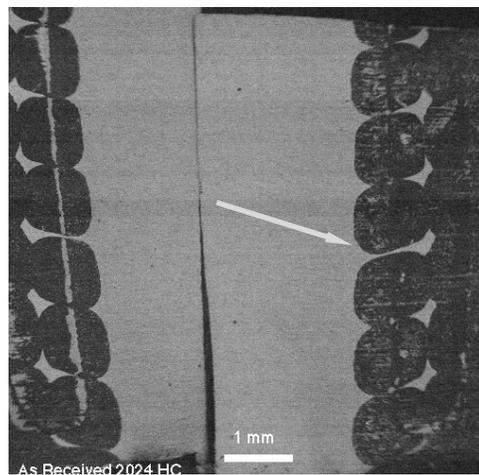
Post failure analysis has revealed that the node bond adhesive from at least one core supplier is applied to the aluminium during manufacture of the core as a series of discrete dots rather than as a continuous film (see Fig. 10). Should the cell wall node bonds not form a complete cover, leaving gaps in the core adhesive, these gaps would increase the rate of moisture progression through a sandwich panel. Node bond failures on one particular brand of core, although appearing to be adhesion node bond failures, are in fact cohesion failures. Optical and electron microscopical examinations have revealed the presence of adhesive on both failure surfaces (see Fig. 11). On other core material, node bond adhesive is peeling from the surface interfacially. Aeronautical and Maritime Research Laboratories (AMRL) (Melbourne) showed that the different forms of failure correlate with two core manufacturing companies. The manufacturers use different core node bond adhesives, and one appears to have a lower durability than the other. Different surface preparation procedures prior to bonding the foils together may also contribute to the interfacial failure mode.

Figure 10. Magnified view of an adhesive strip used to bond the foils together at the nodes.

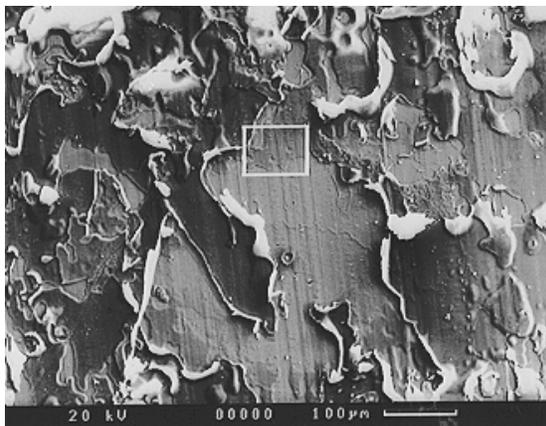
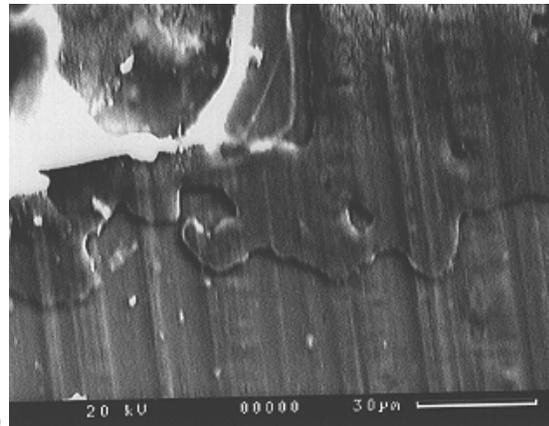
Figure 11. Close-up photograph of a core node bond region taken from the F-111 glove panel. Note the core node bond adhesive peeling off the surface of the cell walls. The magnified region in Fig. (b) shows the presence of what appears to be residual adhesive on the core surface.

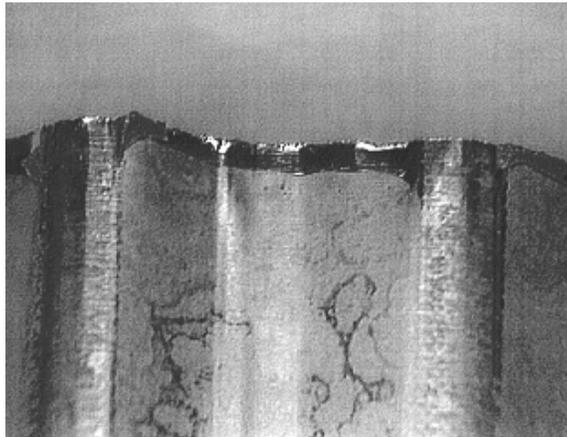
Observations by the RAAF indicate that adhesion fillet bond degradation is typically interfacial (see Fig. 12). The shiny appearance of the fillet bond region of the core foils suggests the region had been

experiencing fretting abrasion due to relative movement between the core foil and the adhesive on the face sheet. Such interfacial (adhesion) failures are usually associated with bonding surfaces with a low resistance to hydration [2]. This appears likely with the fillet bond because there is no available method for preparation of core material prior to bonding to the face sheet adhesive (apart from solvent cleaning which does not affect the oxide layer). The inadequately prepared surface will be susceptible to hydration of the chemical bonds between the metallic surface and the adhesive.

Figure 12. Photograph of a honeycomb core foil showing light surface corrosion which does not extend into the fillet bond area (top of photograph).
