# THE IMPORTANCE OF FAILURE MODE IDENTIFICATION IN ADHESIVE BONDED AIRCRAFT STRUCTURES AND REPAIRS

M.J. Davis<sup>1</sup> and D.A. Bond<sup>2</sup>  
*Aircraft Structural Integrity Section*  
*Directorate General of Technical Airworthiness*  
*Royal Australian Air Force*

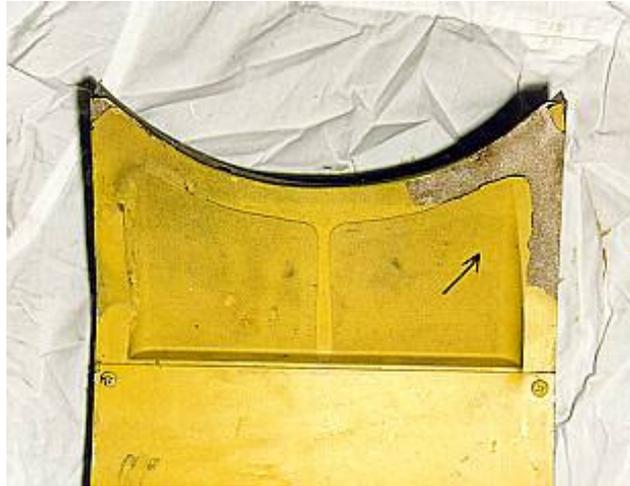
are a substantial number of examples where such philosophies have led to the total failure of the bond. In Fig. 1, an adhesive filler had been added to a panel to dampen vibrations. Because the filler was not expected to carry loads, only a simple surface preparation process was used during manufacture. The subsequent disbond of the insert material led to water entrapment and severe corrosion of the underlying metal.

**Figure 1.** Corrosion damage resulting from moisture entrapment under a failed “non-load bearing” adhesive bond applied after minimal surface preparation.

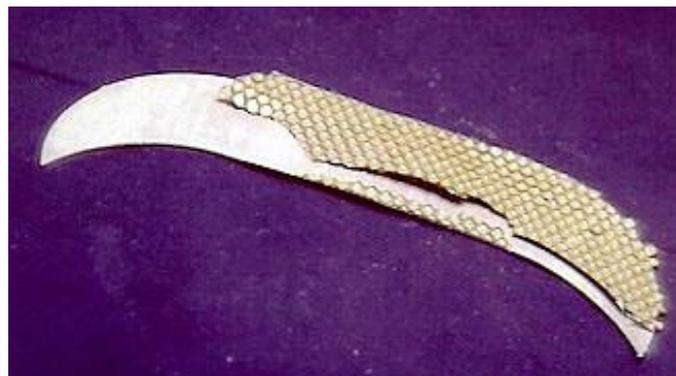
Adhesion failures in sandwich panels may also occur in either the fillet bonds or the node bonds, but may also occur in the skin-to-adhesive interface (see Fig. 9). All skin-to-adhesive failures are invariably a result of adhesion failure, again caused by inadequate or ineffective surface preparation during fabrication. Impact or fatigue will only produce an interfacial skin-to-adhesive failure in a poorly bonded sandwich panel.

Figure 9. Skin-to-adhesive cohesion failure in a sandwich panel. Note that the component also presented a core-to-adhesive fillet bond failure.

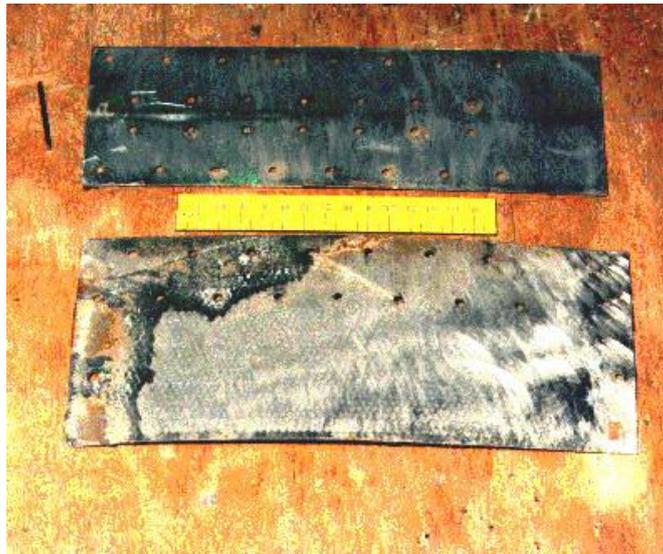
Failure modes for bonded repairs are the same as for bonded structure; either by cohesion or adhesion failure, with most failures occurring by adhesion failure due to the ineffectiveness of approved surface preparation procedures (see Fig. 14). A significant reason for the poor standing of adhesive bonding within some areas of the aerospace community has been the occasional exceptionally poor performance of adhesive bonded repairs, even when these repairs have been performed in accordance with aircraft structural repair manuals [9]. An example of this lack of confidence is the USAF mandate that all bonded repairs must be able to carry ultimate load *in the absence of the bonded repair* [7]. In contrast, the RAAF, using their own bonding procedures and extensive trade training, have used adhesive bonded repairs for cracked metallic aircraft structures since 1975, with great success and have achieved large savings in aircraft maintenance costs, even on cracks in primary structure [22]. Bonded repair failures are often discounted by manufacturers on the basis that the repair was installed incorrectly and this is an argument which is difficult for operators and repair stations to refute. However, RAAF experience suggests that the surface preparation processes recommended by some manufacturers are often inadequate for the repair requirements. This, when combined with the limited training of most technicians installing such repairs almost guarantees an unsuccessful bond. Consequently, there is a requirement for original equipment manufacturers to provide evidence that their approved repair methods are valid and provide a durable repair and an equal requirement for maintenance organisations to ensure that their staff are adequately trained in the installation of such repairs.

**Figure 14.** An adhesively bonded patch which has suffered adhesion failure in service.

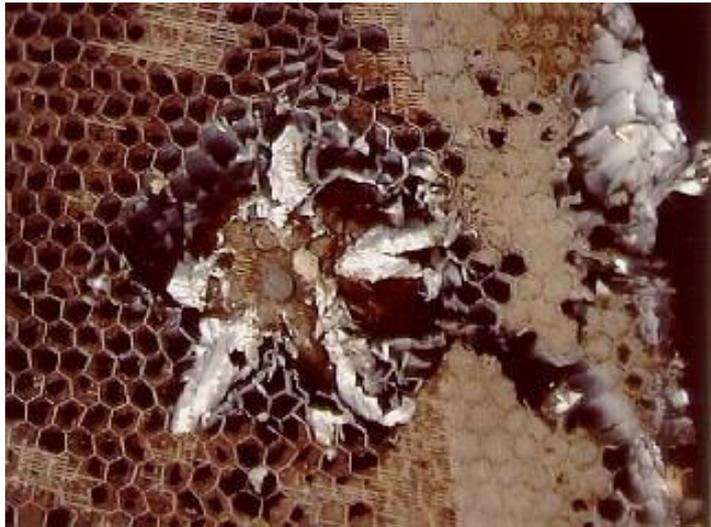
Service exposure of panels repaired by injection frequently results in moisture entry through the injection holes and the initiation of corrosion damage (see Fig. 17). Repair of secondary damage due to past injection repairs constitutes a major proportion of the bonding workload in support of RAAF F-111 aircraft and as a consequence a proposal to prohibit injection repairs is being considered.

**Figure 17.** Corrosion damage due to a previous injection repair in a honeycomb sandwich panel.
