DAVIS, M.J., Chester, R.J., Perl, D.R., Pomerleau, E., Vallerand, M., *Honeycomb Bond and Core Durability Issues; Experiences within CREDP Nations*, Aging Aircraft Conference, Williamsburg, VA, Aug 31-Sep 02 1998.

## **HONEYCOMB BOND AND CORE DURABILITY ISSUES; EXPERIENCES WITHIN CREDP NATIONS**

M.J. Davis, R.J. Chester, D.R. Perl, E. Pomerleau, M. Vallerand<sup>1</sup>  
F/A-18 Composite Repair Engineering Development Program (CREDP)

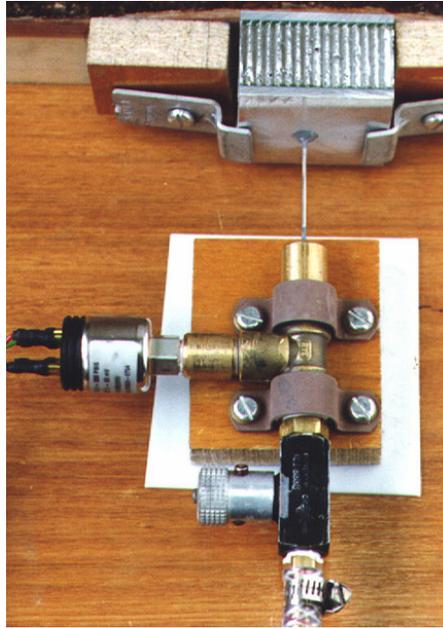
A new technique is being developed at AMRL in an attempt to obtain some quantitative information on degradation present in fillet and node bonds on panels in service. The technique involves measurement of internal pressure in an individual honeycomb cell (see Fig. 13). By measuring pressure in the cell as the temperature is increased, the presence of water can be detected by a pressure increase due to the partial vapour pressure of the water. However, the presence of water in itself cannot confirm degraded bondlines, as this is related to the time the water has been in the cell and the types of interfaces present.

Figure 13. The gas injection tube system, pressure sensor and needle valve for pressure regulation used to detect moisture and to determine cell node bond strength.
